How it Works: Sedimentation Ponds

Mud Creek **Sediment Ponds**

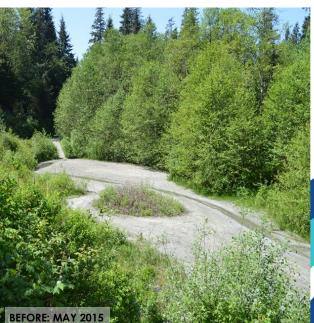
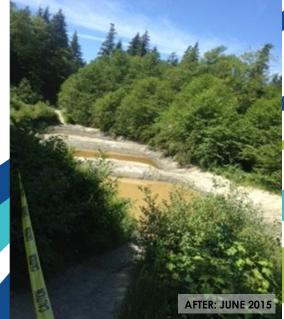
In June of 2015 there was a total of 2350 cubic meters of sediment removed from the site as shown in the before and after pictures.

Mud Creek sediment ponds are temporary basins built on the bottom of an eroded slope side to capture disturbed soils and silt that is washed downward during rain events. This design is put in place to protect the water quality of nearby rivers, streams or lakes, in this case the South Alouette River, and subsequent impacts of multiple species spawning and rearing habitat. At the base of last sediment pond, before entering the South Alouette River, there is a weir which acts as a dam. pooling water behind it while also allowing water to flow steadily over the top. Mud Creek sediment ponds have been maintained for over 20 years. However because the ponds are constantly filtering and being filled with sediment they must be excavated every six to seven years.
